Project memo

Video-based traffic counting

Registrations for the SUSTRANS project

This document describes initial results and findings from video-based traffic counting in Geiranger. An automatic video analysis system developed by SINTEF was tested and utilised to provide traffic counts for the SUSTRANS project.

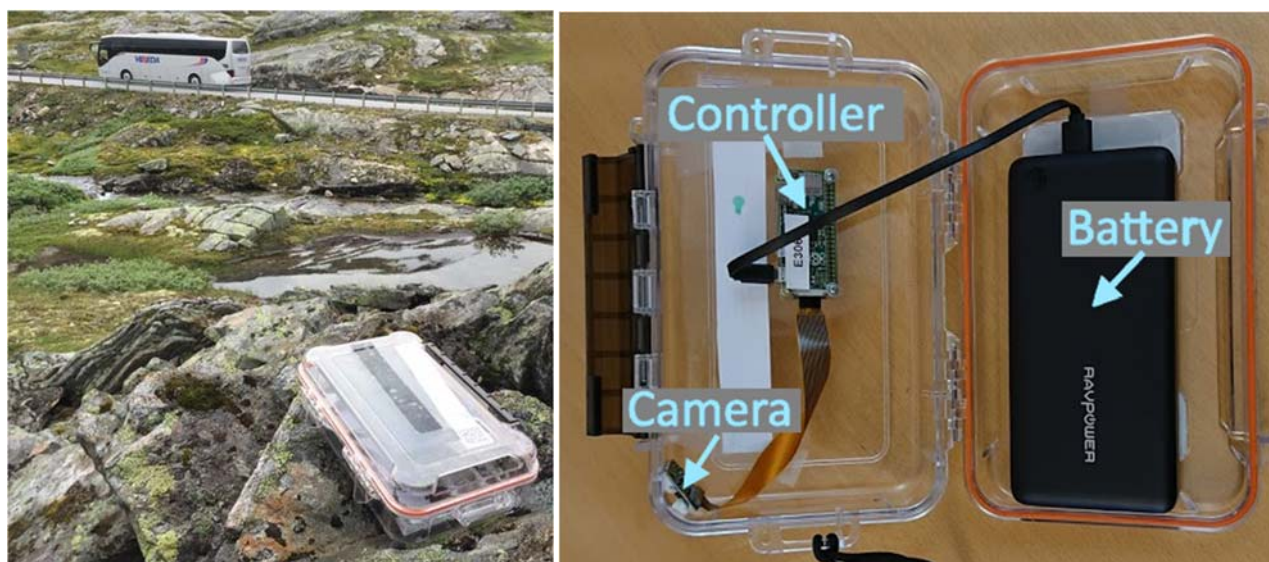
Figure 1 Left: A recording unit placed on the road side, recording a passing bus. Right: A recording unit opened to show the controller (a Raspberry Pi Zero v1.3), the camera (an RPi Camera v2) and a battery (a RavPower 26800mAh power bank).

The controller and the camera are very small, but in order to power them for five days, a large battery is required. As seen in Figure 1, most of the space inside the box is taken by the battery. For shorter periods of time, the battery (and thus the entire recording unit as well) could be made much smaller.

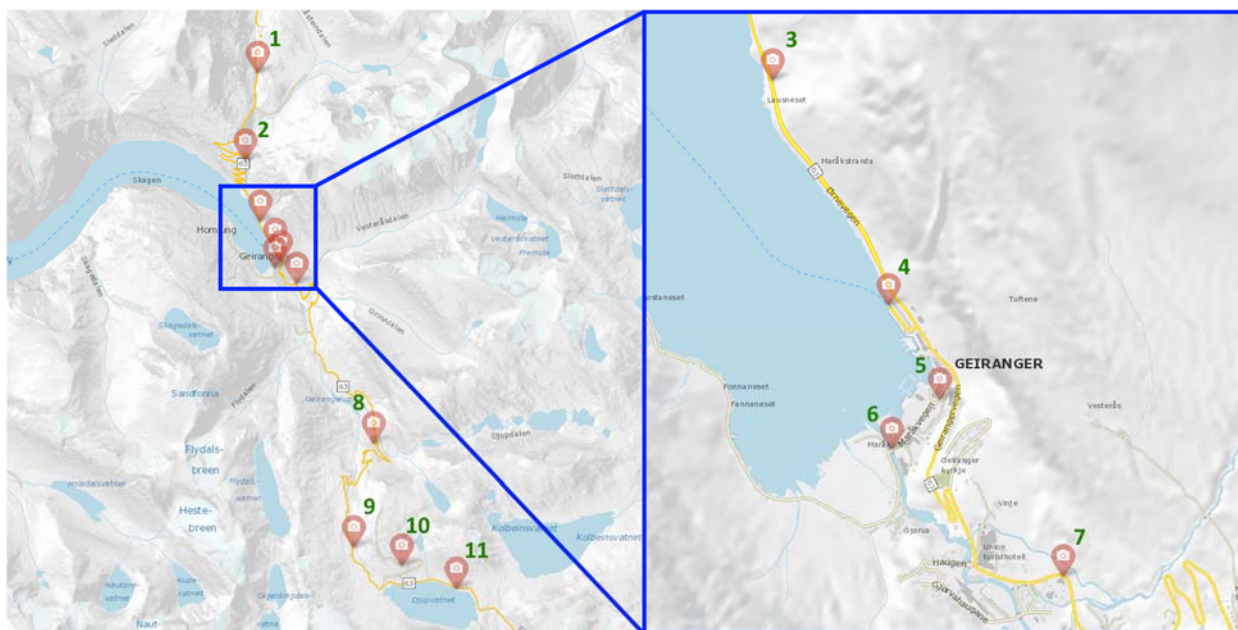
Figure 2 A map showing the 11 recording units that delivered usable data.

In total 13 recording units were deployed in and around Geiranger. Two of these units were misconfigured, and collected no data: one unit before the parking lot above Ørnesvingen (slightly south of #1), and one at Fjordbua (south of #4). The map in Figure 2 shows the 11 remaining units that gave usable data.

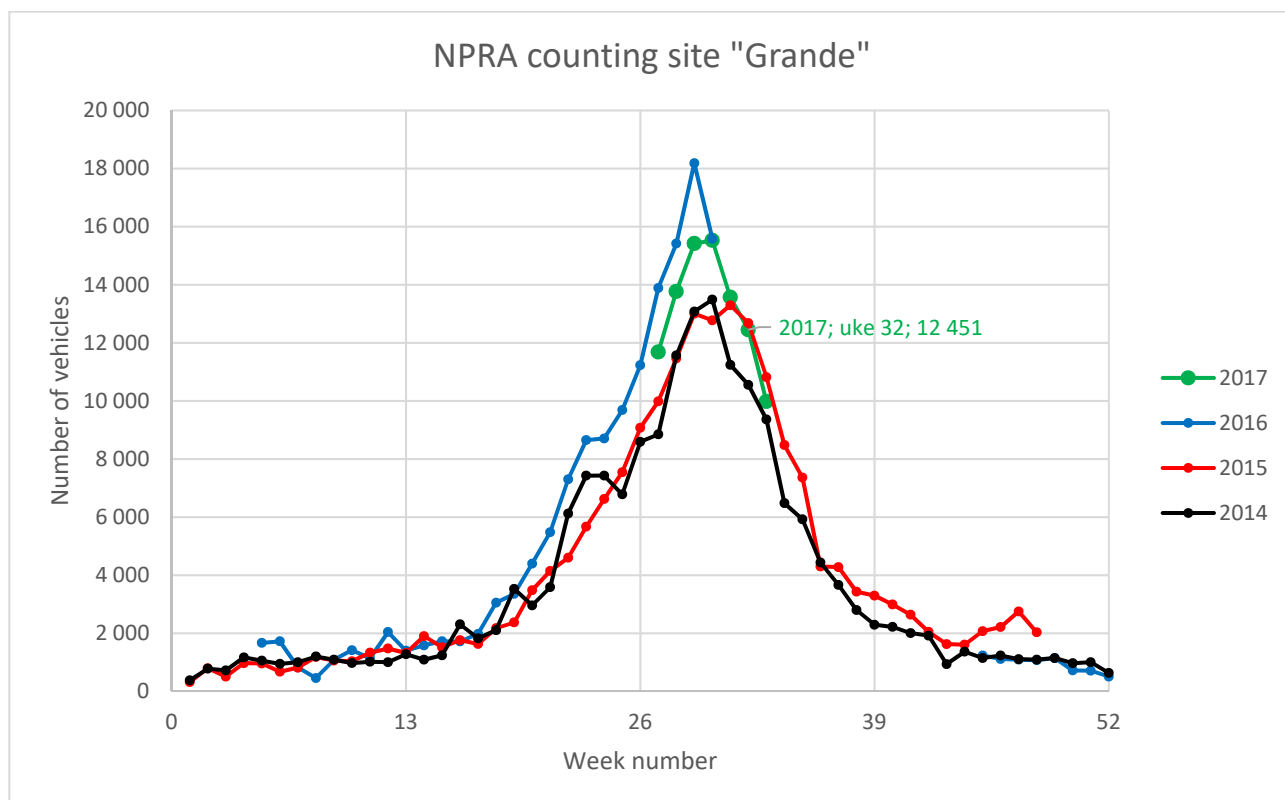
Figure 3 The number of vehicles passing the NPRA counting site "Grande" every week of the year from 2014 to 2017.

As shown in Figure 3, traffic levels at the NPRA counting site Grande has peaked around week 29-30 the previous years. Ideally, the video recording period should have been conducted in this period, in order to capture the peak traffic situation in the area. For practical reasons however, recordings could not start until early August 2017.

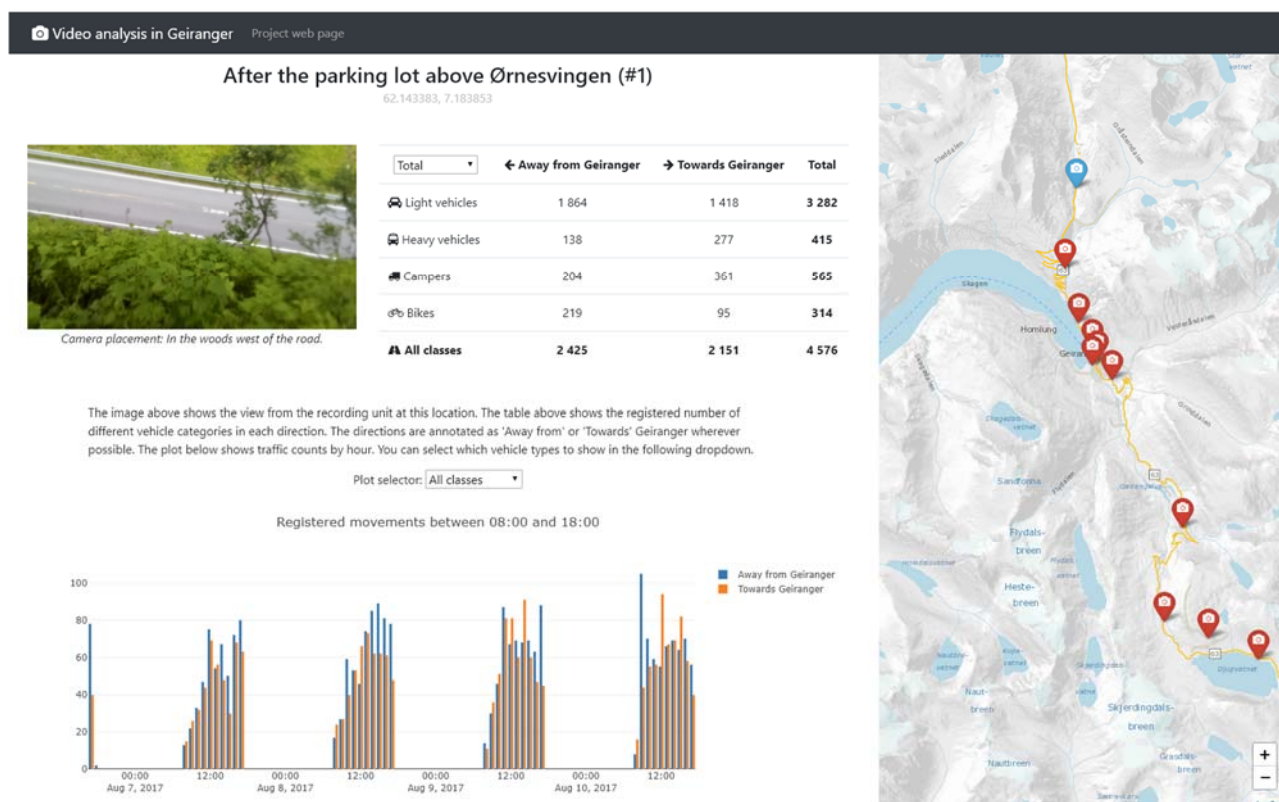
Figure 4 A web page that shows the results from each of the recording sites.

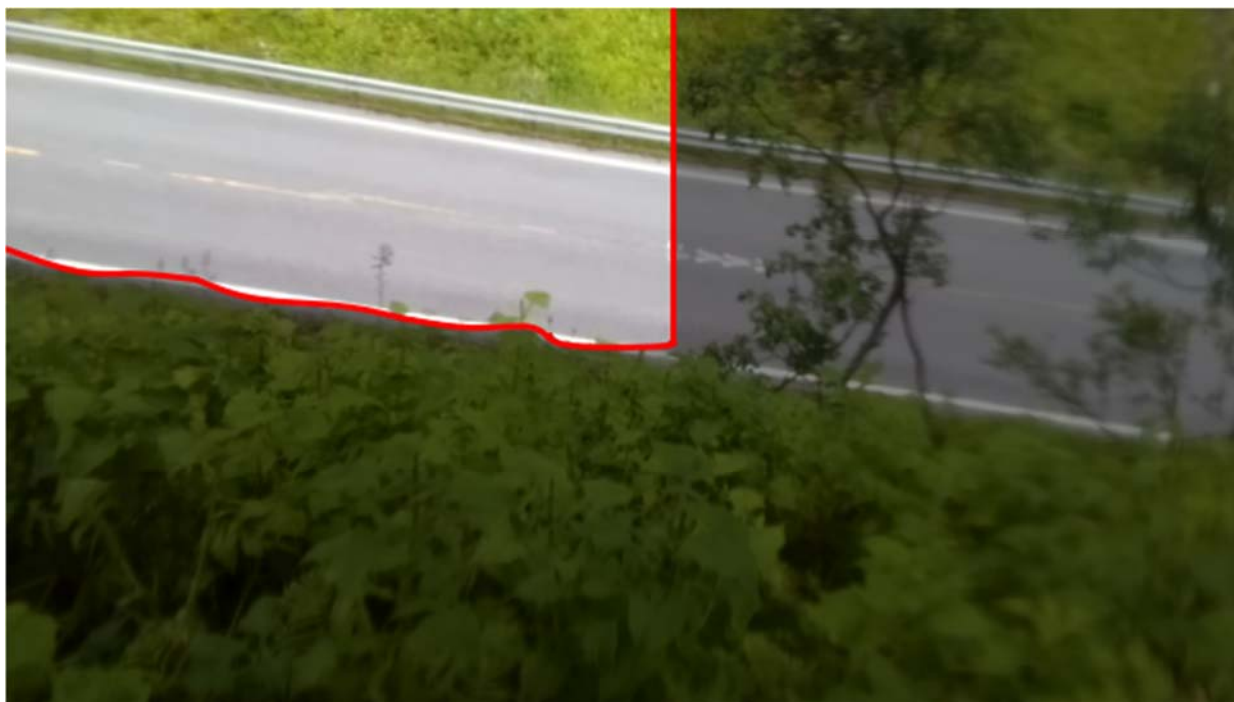
Large amounts of vegetation and a slightly low camera angle reduced the quality of the data in this location. The usable area was just large enough to work, but too small to reliably identify passing vehicles (especially in the upper lane, driving away from Geiranger, as seen in the table).

Figure 5 The full view (the entire image) and the recording area (the bright area inside the red border) for this recording unit.

Vehicles driving from left to right on this image are driving towards Geiranger.

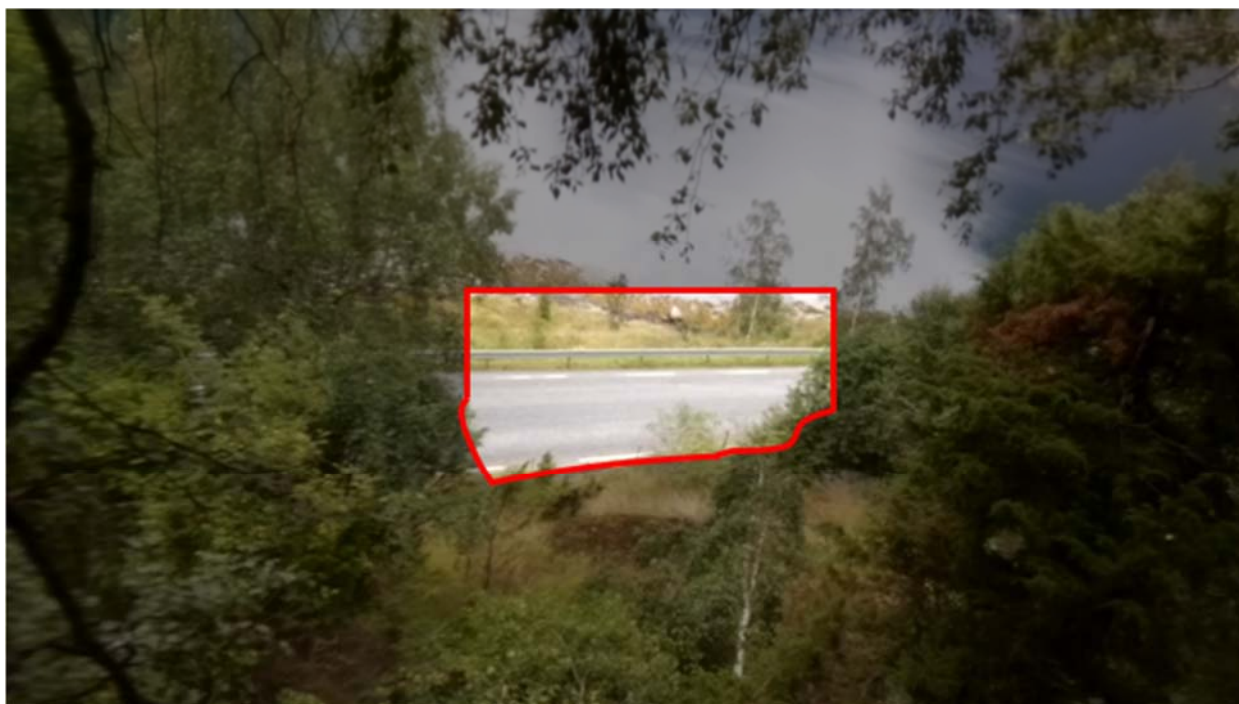
Because of the road and the surrounding terrain, this unit had to be placed far away from the road, behind a lot of vegetation. Still, the usable area was just large enough to catch all types of vehicles.

Figure 6 The full view (the entire image) and the recording area (the bright area inside the red border) for this recording unit.

Vehicles driving from right to left on this image are driving towards Geiranger.

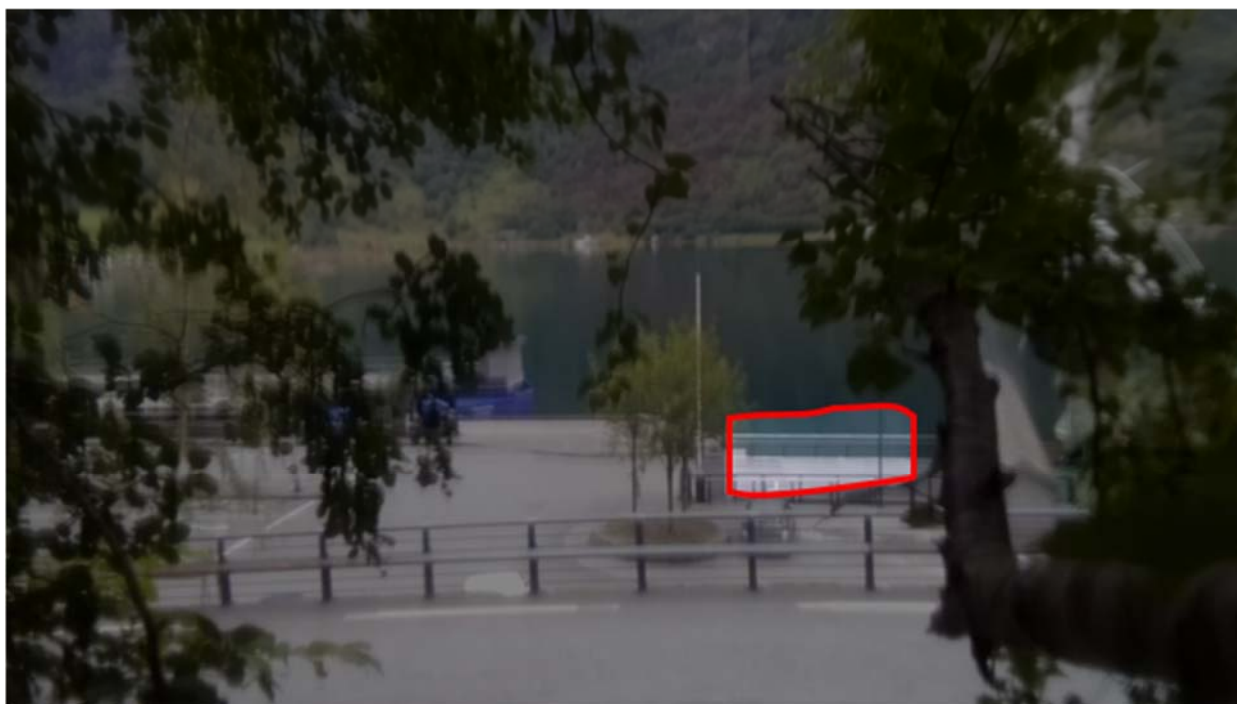
It was very hard to find a good spot with a good angle on the ferry gangway, so the view is very poor. There is also water in the background, which gives a lot of movements that has to be filtered. This caused problems for the large vehicles, but the system was relatively precise on the number of pedestrians. There is also a lot of traffic on the road in the lower part of the image, which often blocks the view of the gangway, and disturbs the counting at this location.

Figure 7 The full view (the entire image) and the recording area (the bright area inside the red border) for this recording unit.

Vehicles driving from left to right on this image are embarking the ferry.

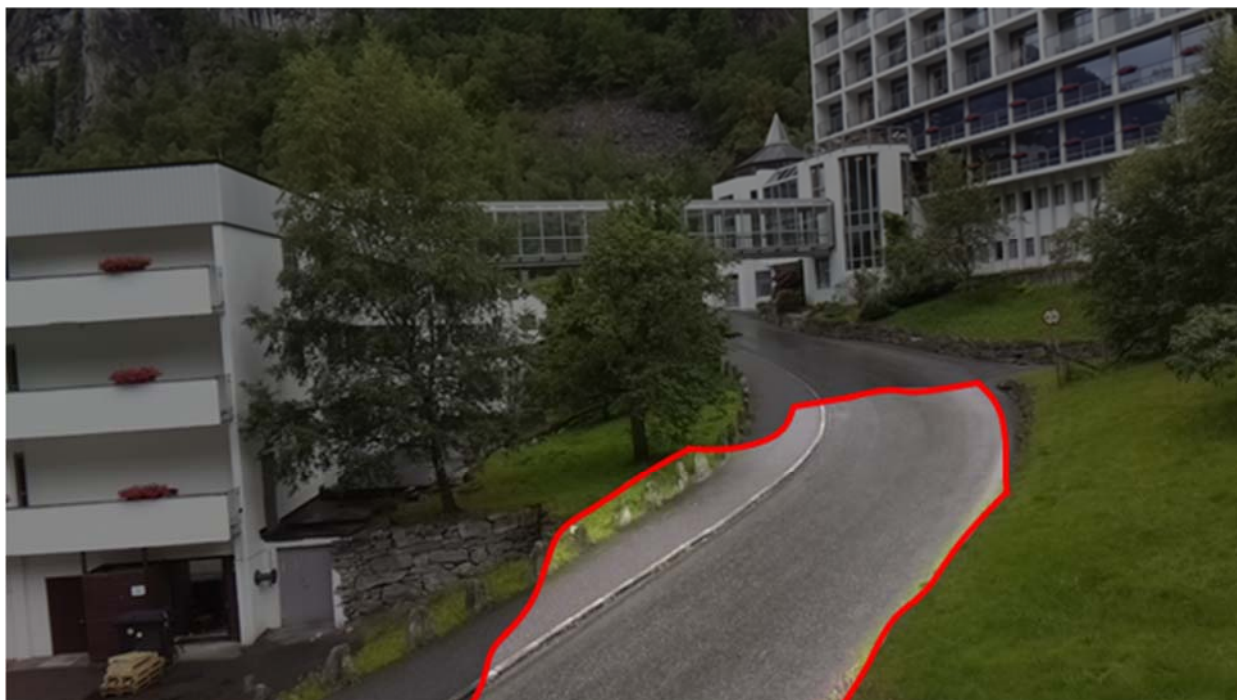
This unit had a good view of the road, but the viewing angle could have been better. Tourists moving in groups are very hard to count correctly, which causes a large error in the pedestrian row of the table.

Figure 8 The full view (the entire image) and the recording area (the bright area inside the red border) for this recording unit.

Vehicles driving from bottom to top on this image are driving away from the gallery.

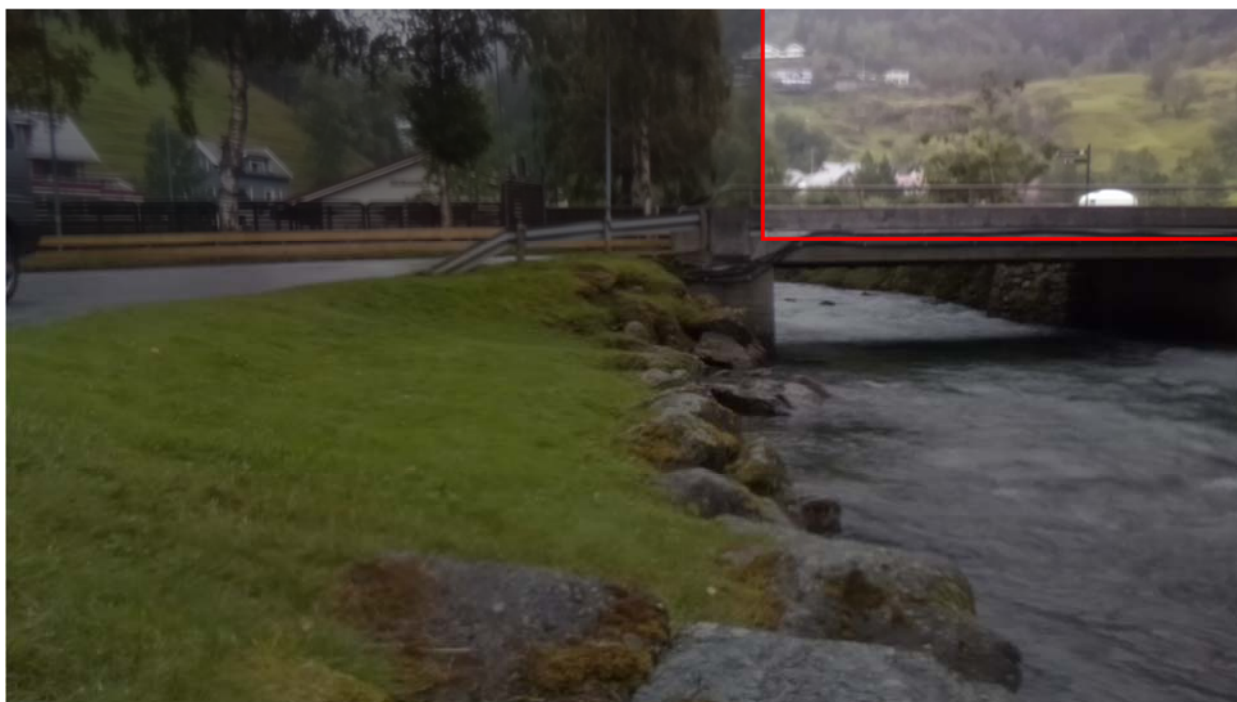
At Geiranger Camping there were no good spots to mount the recording unit, and it had to be mounted on ground level. Therefore, it was often blocked by tourists watching the river, or eating lunch on the grass. There were often large amounts of tourists walking over the bridge simultaneously, so both the analysis and the manual count of pedestrians are probably a bit off.

Figure 9 The full view (the entire image) and the recording area (the bright area inside the red border) for this recording unit.

Vehicles driving from right to left on this image are driving towards Geiranger.

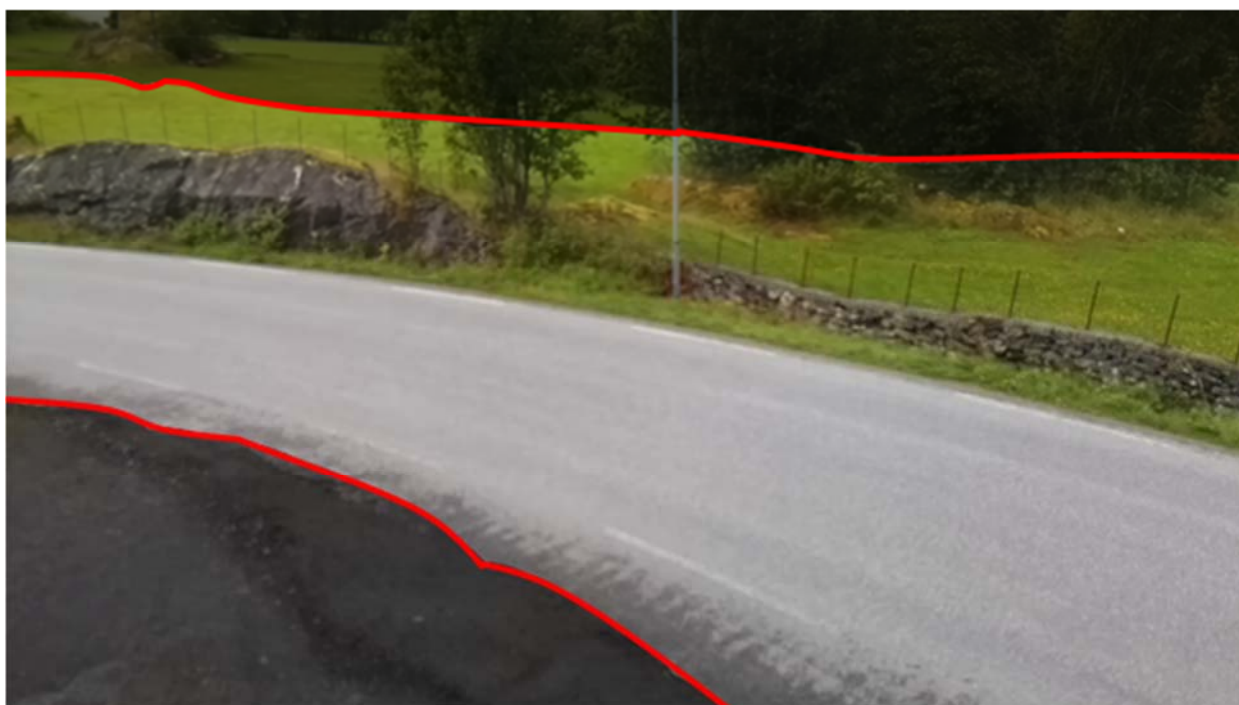
This unit got a very good view on the road from the attic window at Gildetun, and gave very good results. There is some mix-ups between the light and heavy vehicle categories, which is probably caused by medium sized vehicles that are hard to reliably place in the correct category.

Figure 10 The full view (the entire image) and the recording area (the bright area inside the red border) for this recording unit.

Vehicles driving from right to left on this image are driving towards Geiranger.

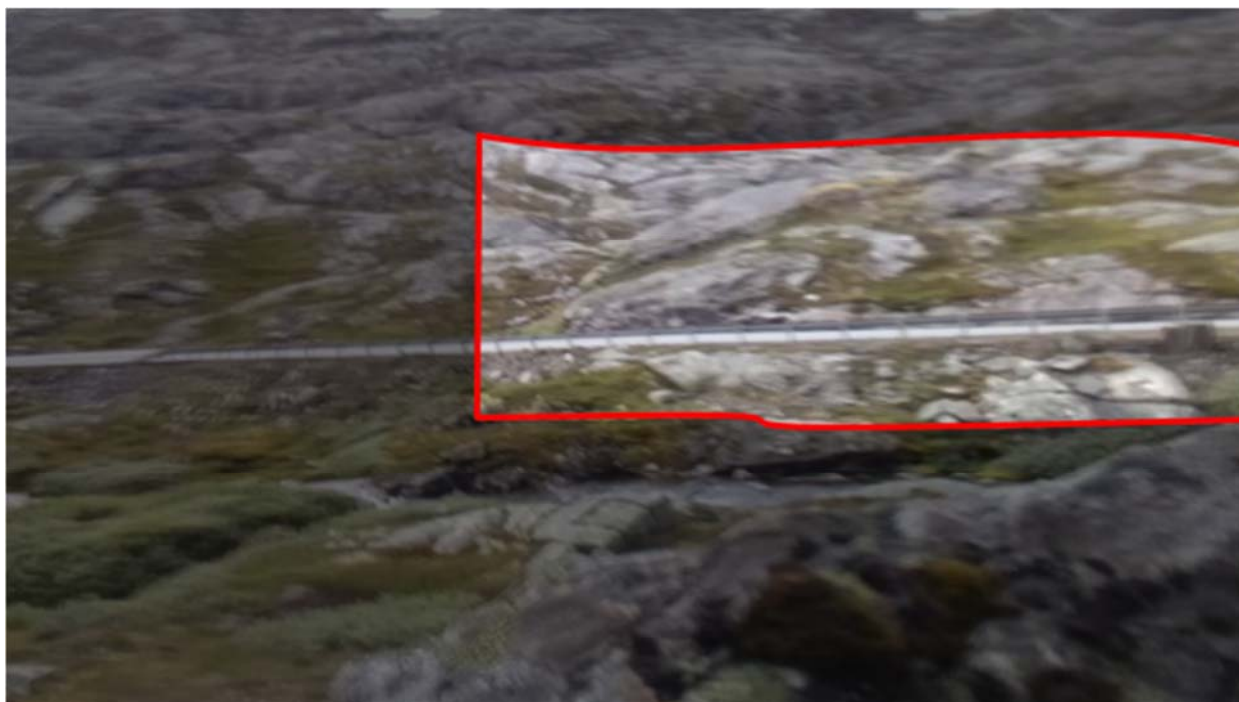
This unit had a good viewing angle, but it was placed so far from the road that it was difficult to catch all the movements. Because of the distance from the road, it is hard to reliably separate the vehicle classes from each other.

Figure 11 The full view (the entire image) and the recording area (the bright area inside the red border) for this recording unit.

Vehicles driving from left to right on this image are driving towards Geiranger.

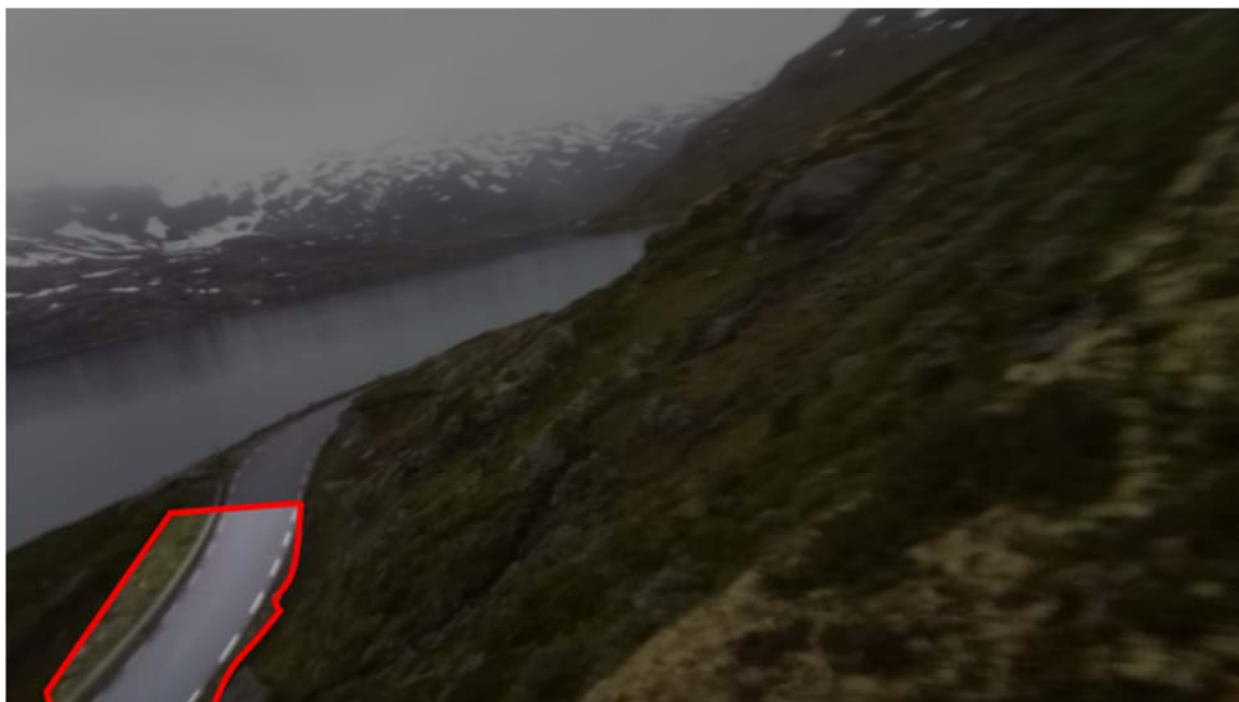
This unit was also placed far from the road, and with a poor viewing angle (not perpendicular to the road). Because of the distance and angle the system has failed to properly separate campers and buses from each other.

Figure 12 The full view (the entire image) and the recording area (the bright area inside the red border) for this recording unit.

Vehicles driving from bottom to top on this image are driving towards Geiranger.

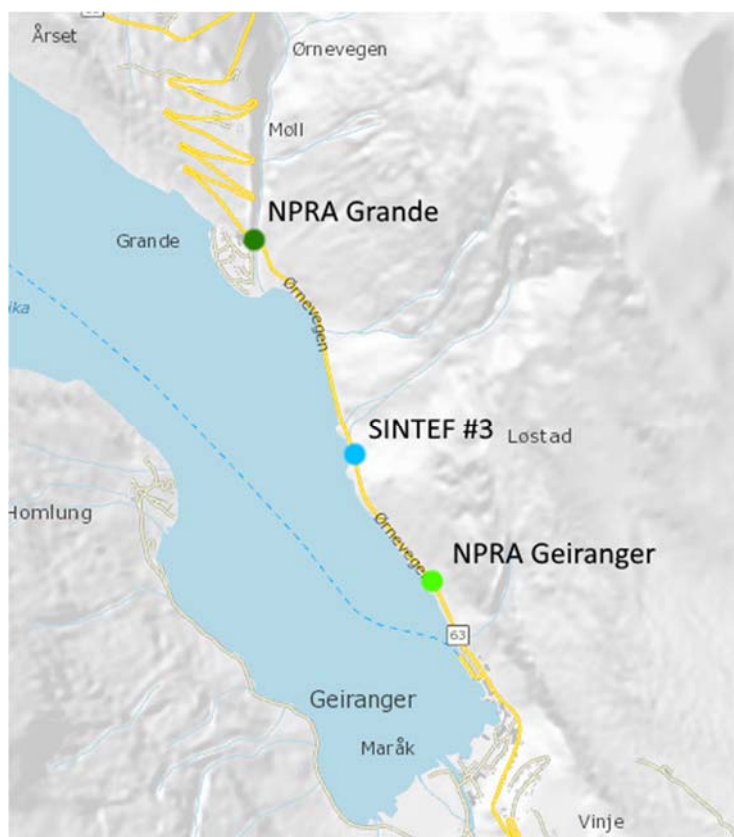
Figure 13 The two NPRA counting sites at Grande and Geiranger are both measuring the same road stretch as SINTEF recording unit #3.

As shown on the map in Figure 13, those are all located on the same road stretch, but not in the exact same locations.

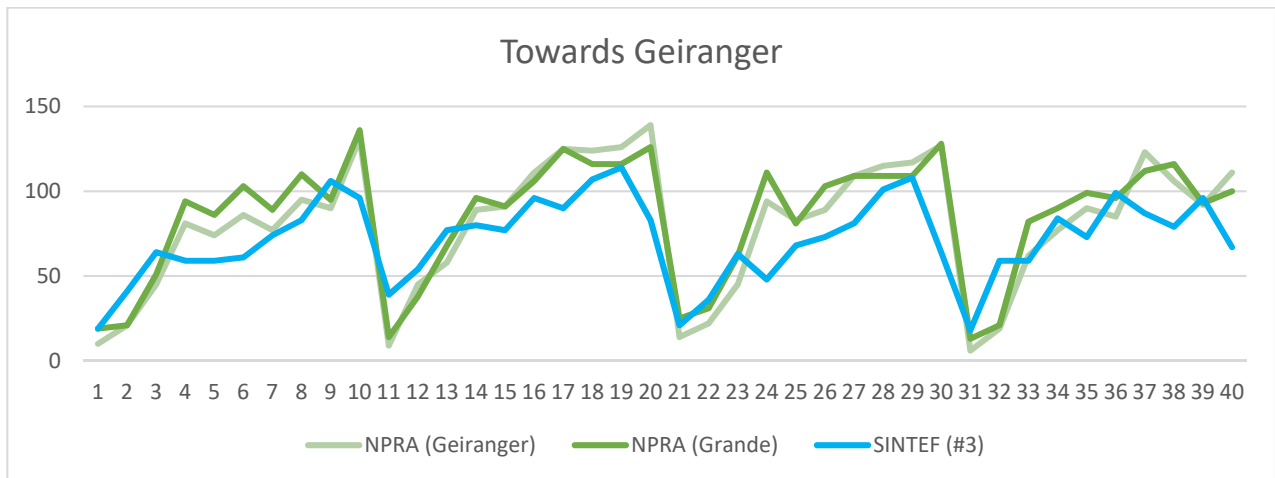
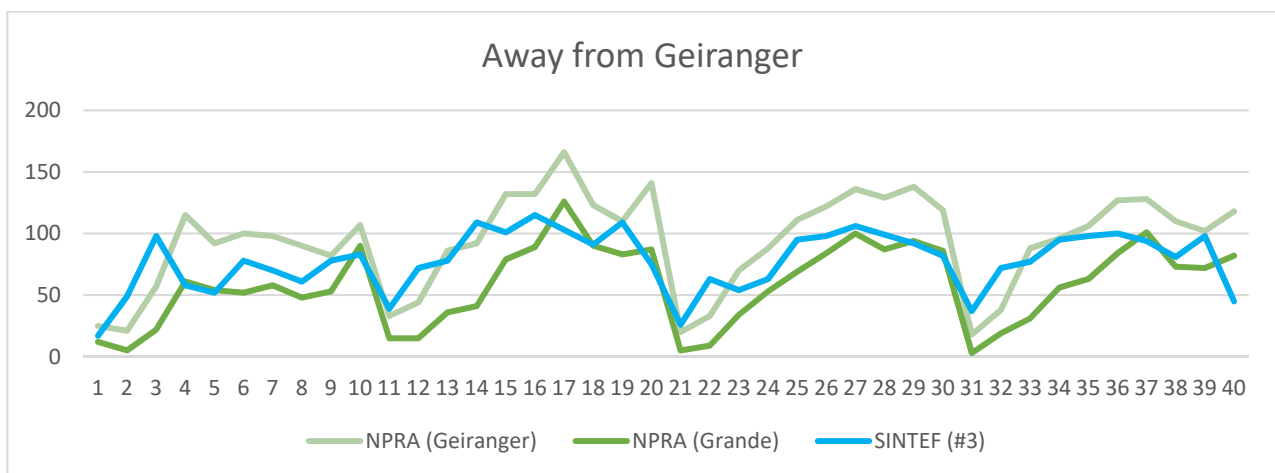
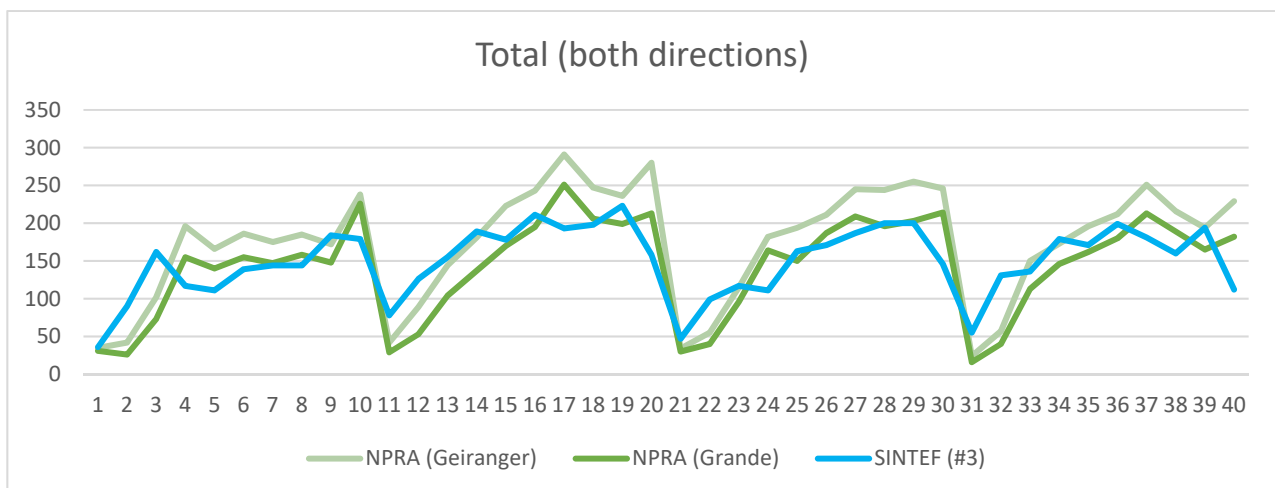
Detailed graphs for the three sites in both directions are shown in Figure 14. The Y axis shows the number of vehicles, while the X-axis shows the active hours of the SINTEF unit (08:00 to 18:00 each of the four days shown). The SINTEF unit is marked with blue colour, while the NPRA sites are different shades of green.

Figure 14 Data from the two NPRA counting sites (shades of green) and the SINTEF recording unit (blue) plotted together. The Y axis shows the number of vehicles passing, while the X axis is the active hours of the SINTEF recording unit (10 hours each day for four days). Top: the lane towards Geiranger. Middle: the lane away from Geiranger. Bottom: the sum of both lanes.

As the graphs shows, all three counting sites delivered very similar data, but none were identical to the others. This can be because of various error sources in both the NPRA sites and the SINTEF units, or because vehicles only drove a part of the road, and/or turned around (there is at least one turning spot slightly north of the SINTEF unit).

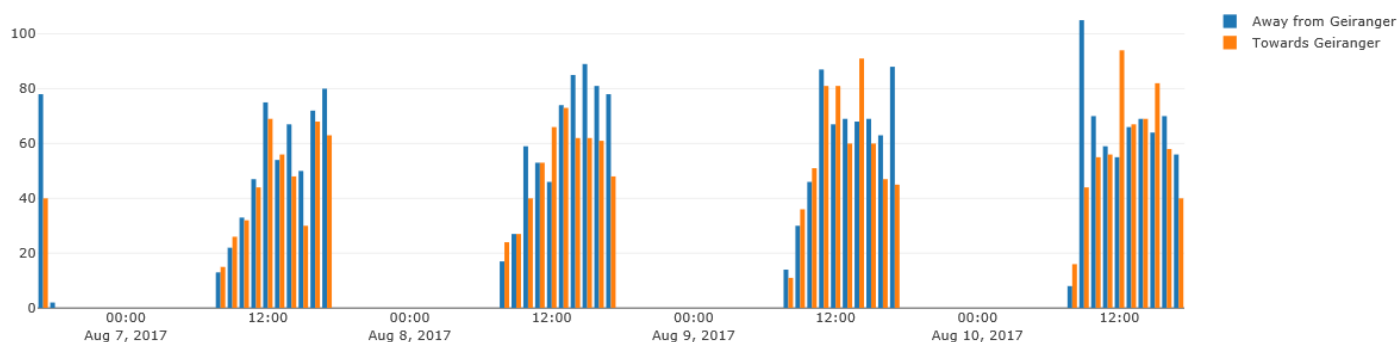
Registration site #1: Total counts by direction and hour

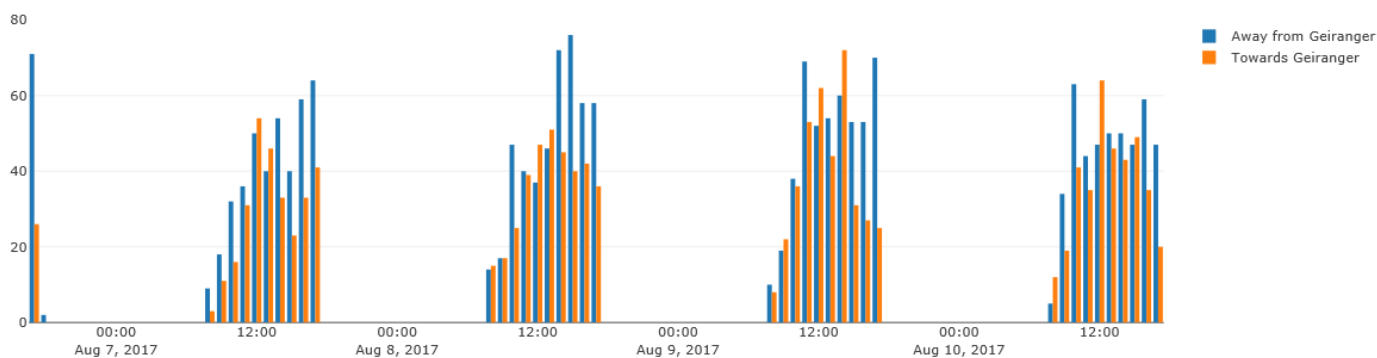
Registration site #1: Counts of light vehicles by direction and hour

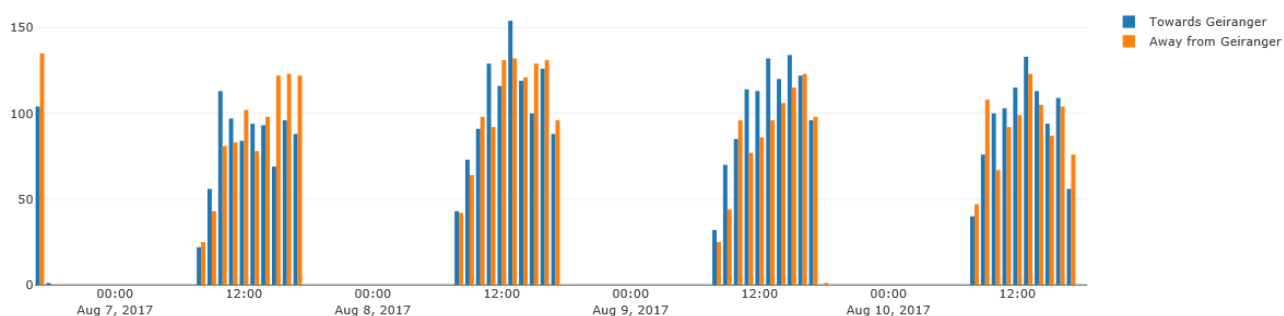
Registration site #3: Total counts by direction and hour

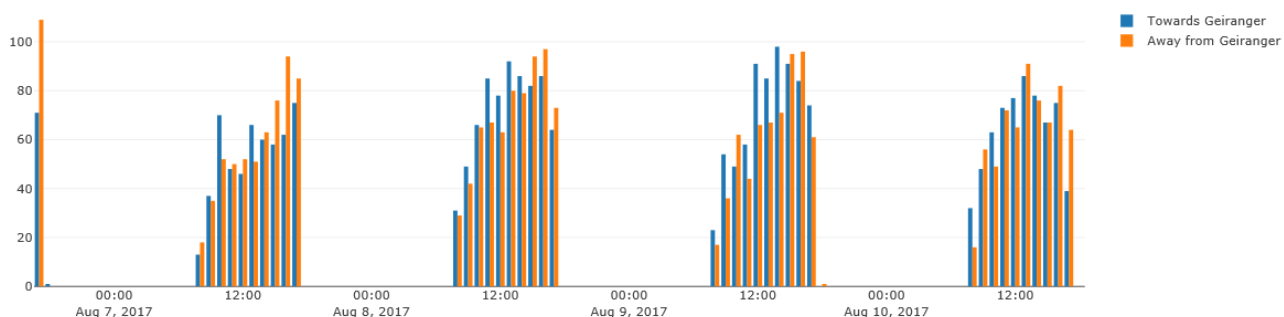
Registration site #3: Counts of light vehicles by direction and hour

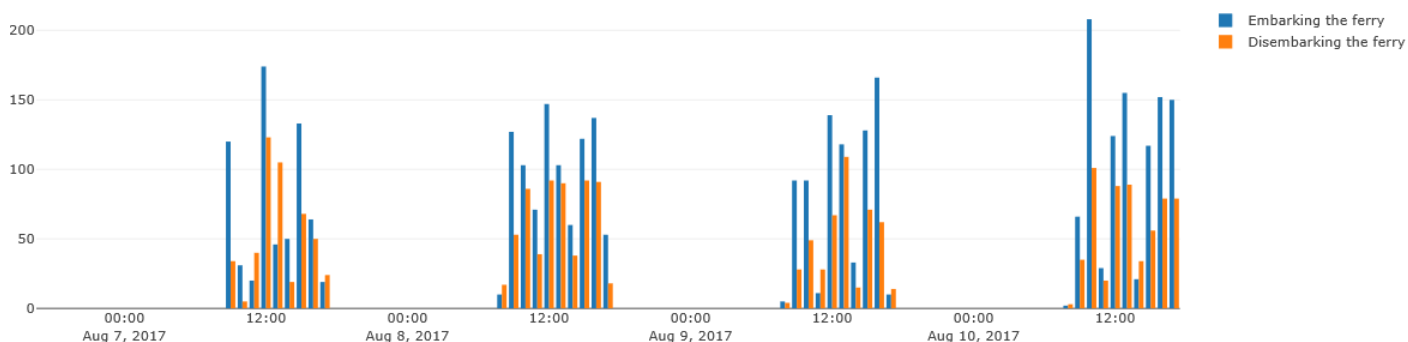
Registration site #4: Total counts by direction and hour

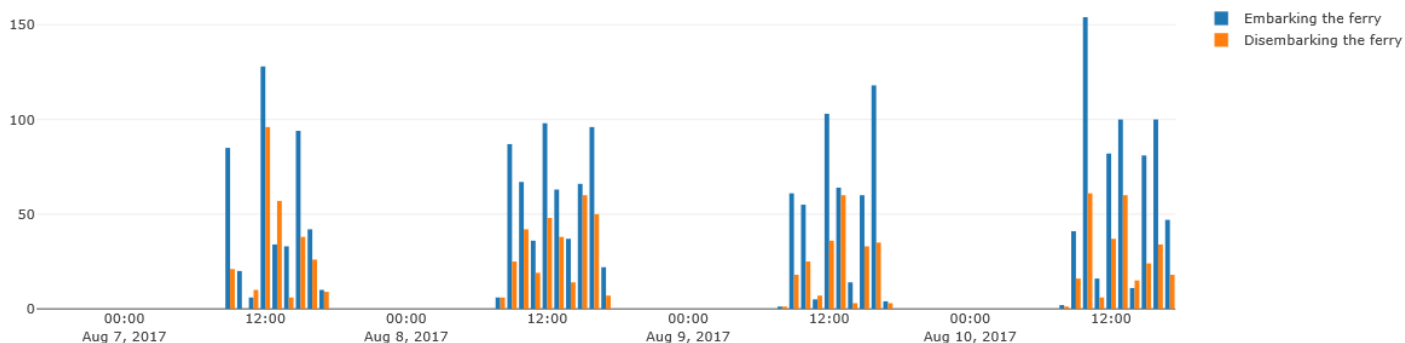
Registration site #4: Counts of persons by direction and hour

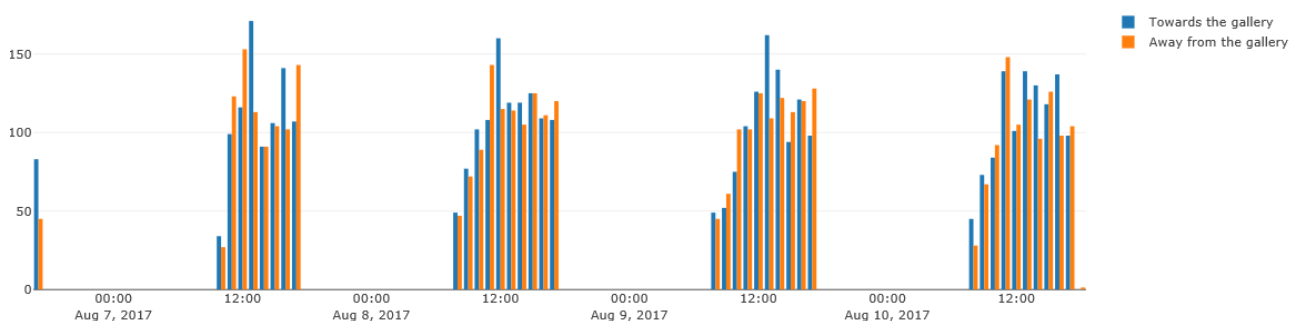
Registration site #5: Total counts by direction and hour

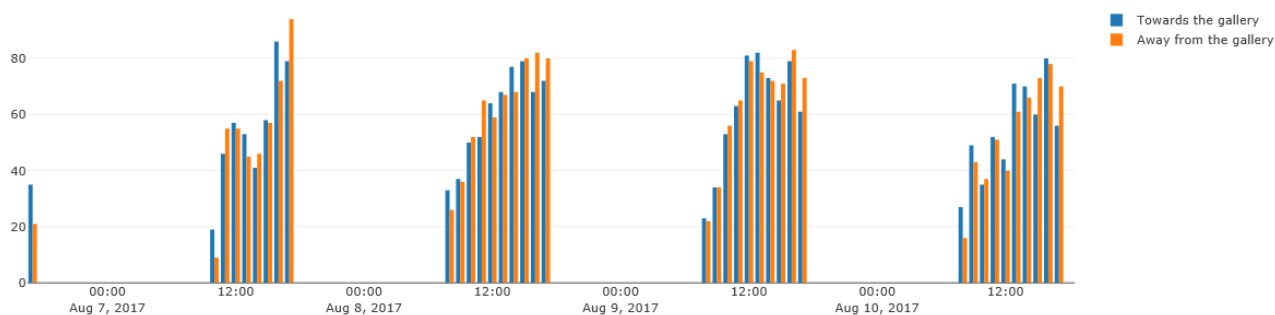
Registration site #5: Counts of light vehicles by direction and hour

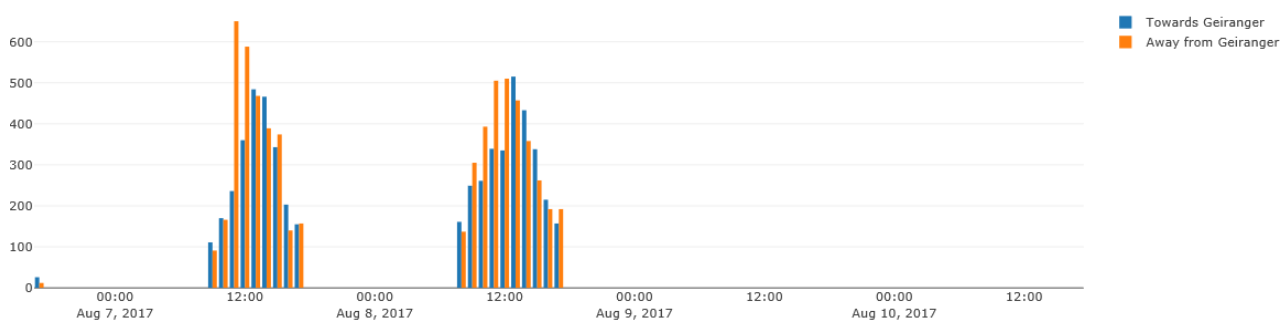
Registration site #6: Total counts by direction and hour

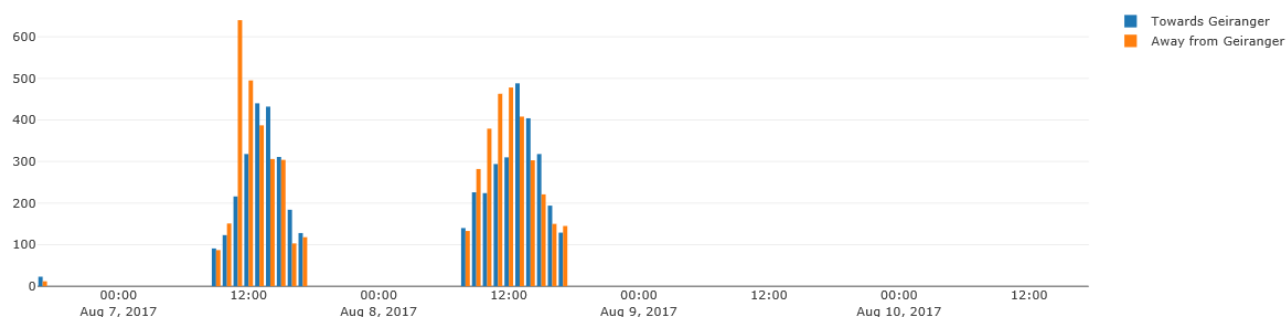
Registration site #6: Counts of persons by direction and hour

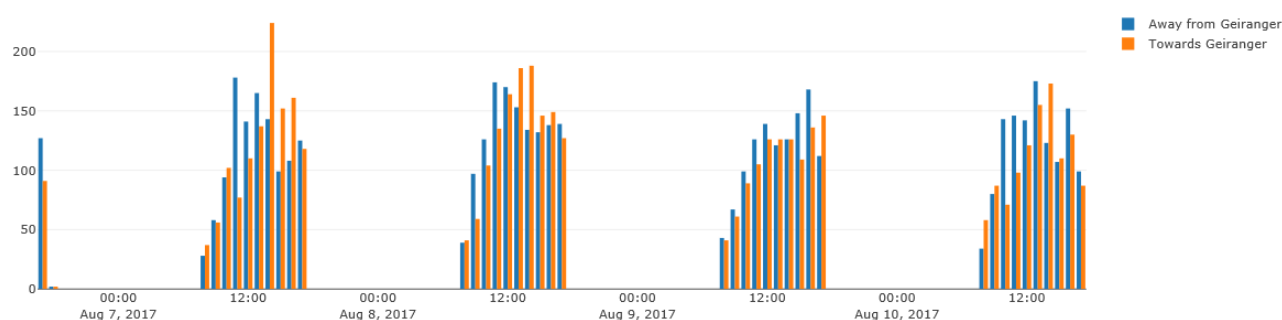
Registration site #7: Total counts by direction and hour

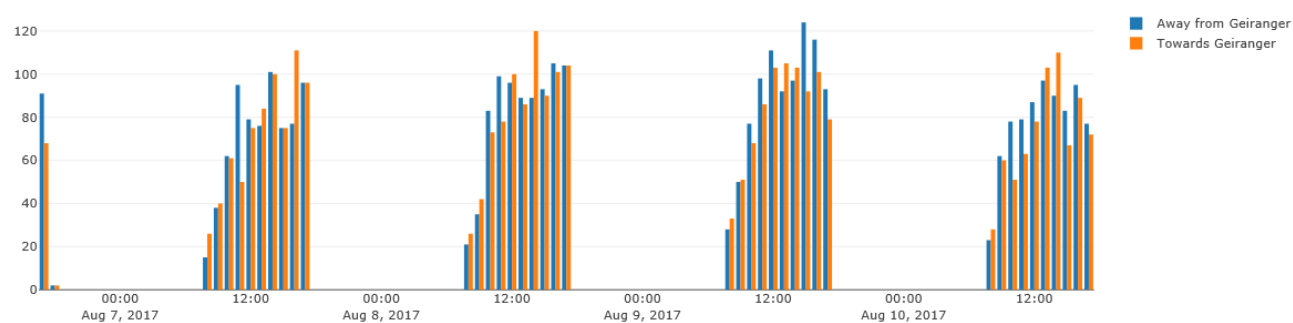
Registration site #7: Counts of light vehicles by direction and hour

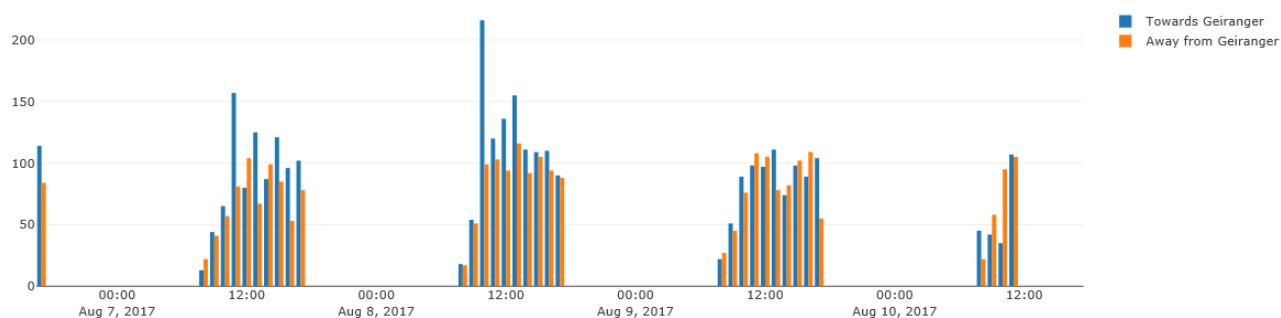
Registration site #9: Total counts by direction and hour

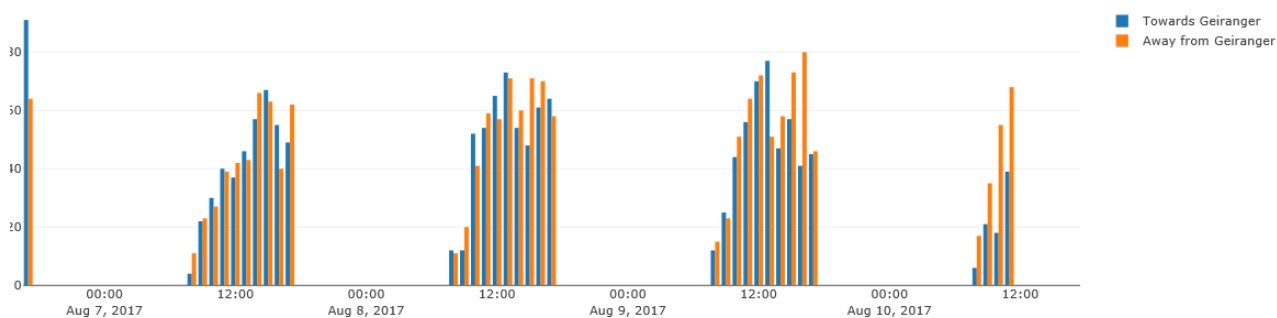
Registration site #9: Counts of light vehicles by direction and hour

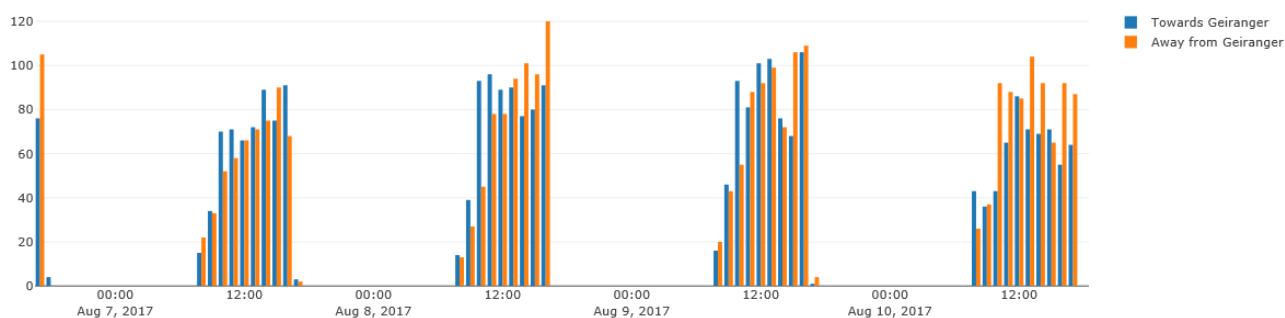
Registration site #11: Total counts by direction and hour

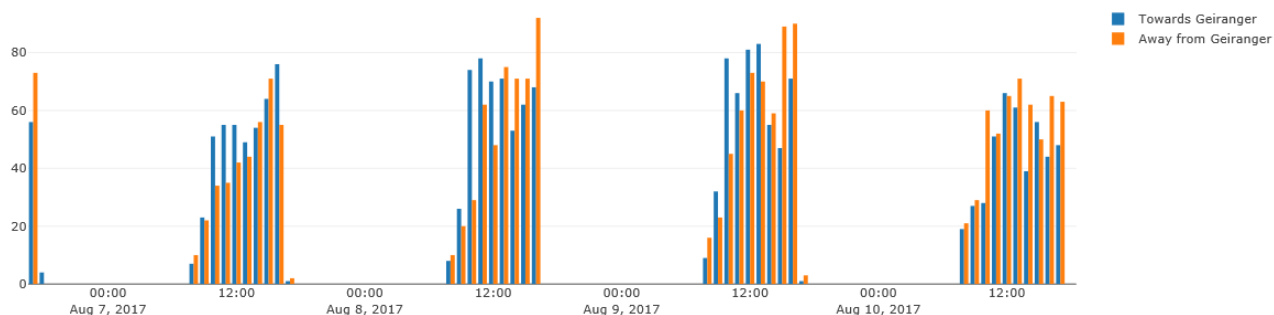
Registration site #11: Counts of light vehicles by direction and hour
